## SAFETY INVESTIGATION REPORT

REPORT NO.: 21/2016

December 2016

## MV MARAKI Collision with MV *Ivory Arrow* In the TSS Crossing between Dover Strait and West Hinder TSS 05 December 2015

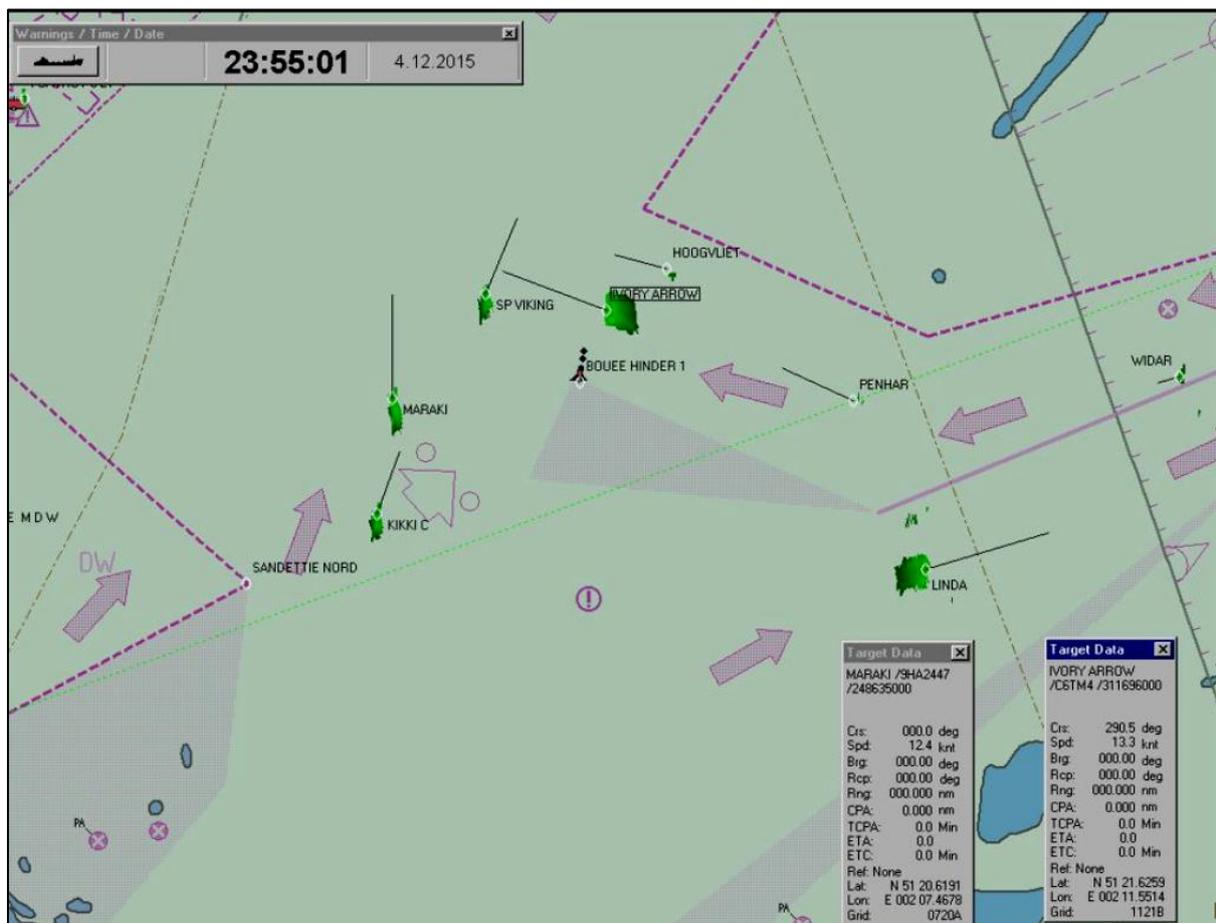
At 2340, the OOW on board *Ivory Arrow* acquired *Maraki*'s target on the S-band radar. The second mate reported a CPA of 0.7 nm with *Maraki* crossing the bow. At 2355, *Ivory Arrow* passed Hinder 1 Buoy on her port side, steering 290° and making 13.3 knots. *Hoogvliet* was on her starboard quarter and *SP Viking* was ahead, crossing her bow from port to starboard (Figure 1). At about 2359, *Maraki*'s master started giving helm orders to starboard.

**Figure 1: VTS image at 2355/01 s, showing vessels in the vicinity of Hinder Buoy 1**

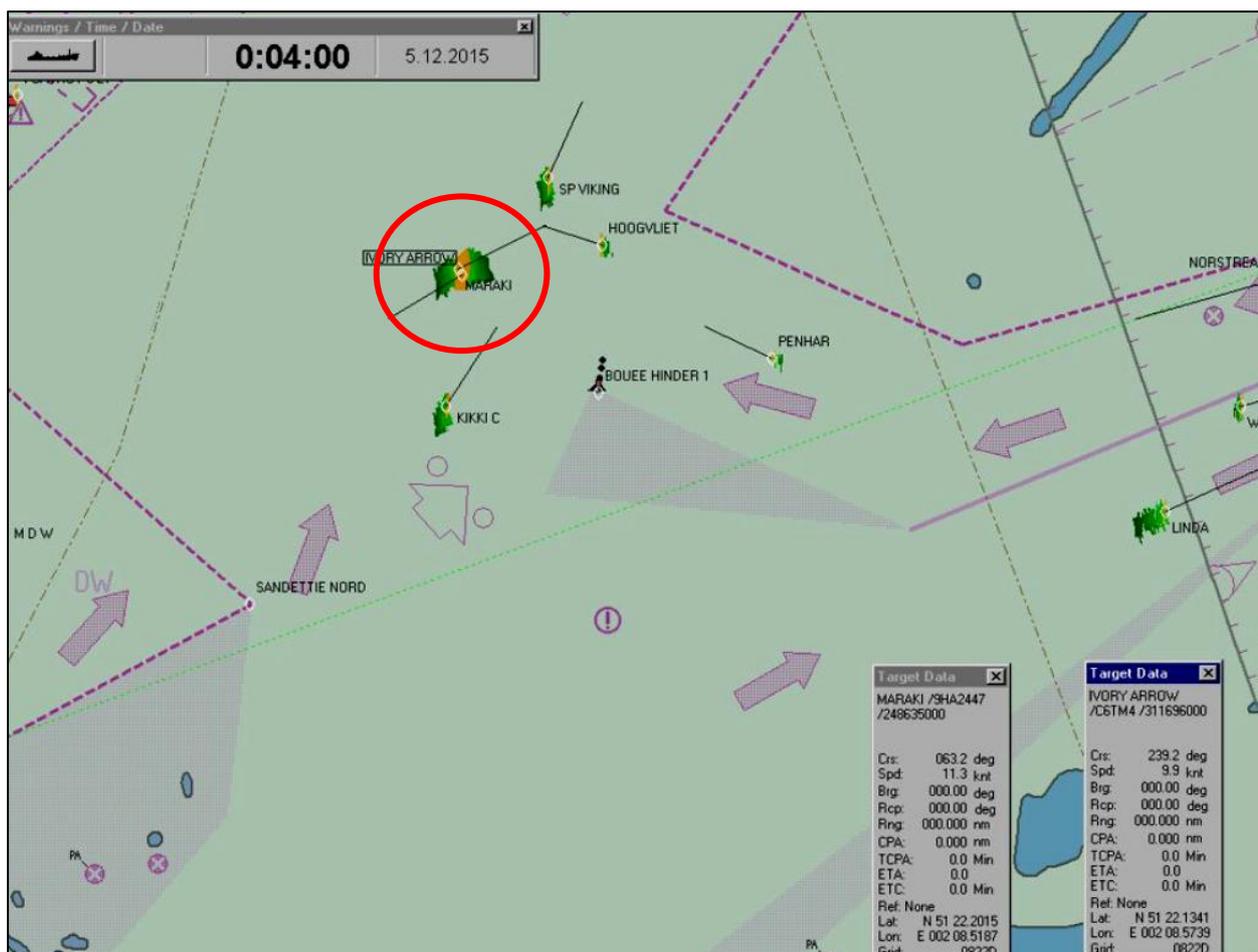
A second contact was made abreast of *Maraki*'s cargo hold no. 5. The collision happened at 0004 on 05 December 2015 in the crossing between Dover Strait TSS and West Hinder TSS in position 51° 22.2' N 002° 08.5' E (Figure 2).

**Figure 2: VTS image at 0004/00s showing position of collision between *Maraki* and *Ivory Arrow***

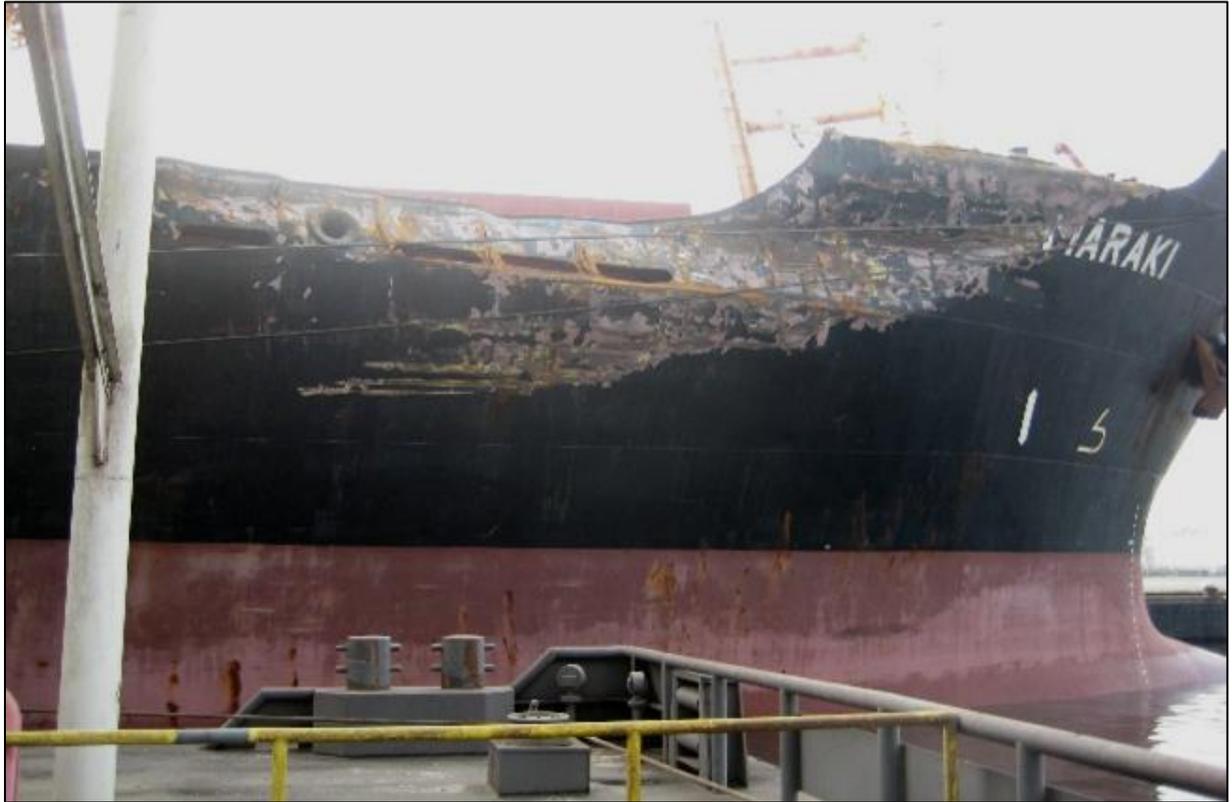
Extensive structural damage was reported by *Maraki*. Her starboard shell plating in way of cargo hold no. 5 between frames 41 and 64, longitudinals (strakes 1 to 4), web frames and brackets were found deformed. The forecastle starboard bulwark, deck and shell plating were indented. On the main deck, in way of cargo hatch no. 1, deck and shell plating up to the break of the forecastle were damaged. The bulwark, log stanchion, web frames, stiffeners and associated members were distorted (Figures 3a and 3b).

**Figure 3a: *Maraki's* shell plate damage iwo cargo hold no. 1**

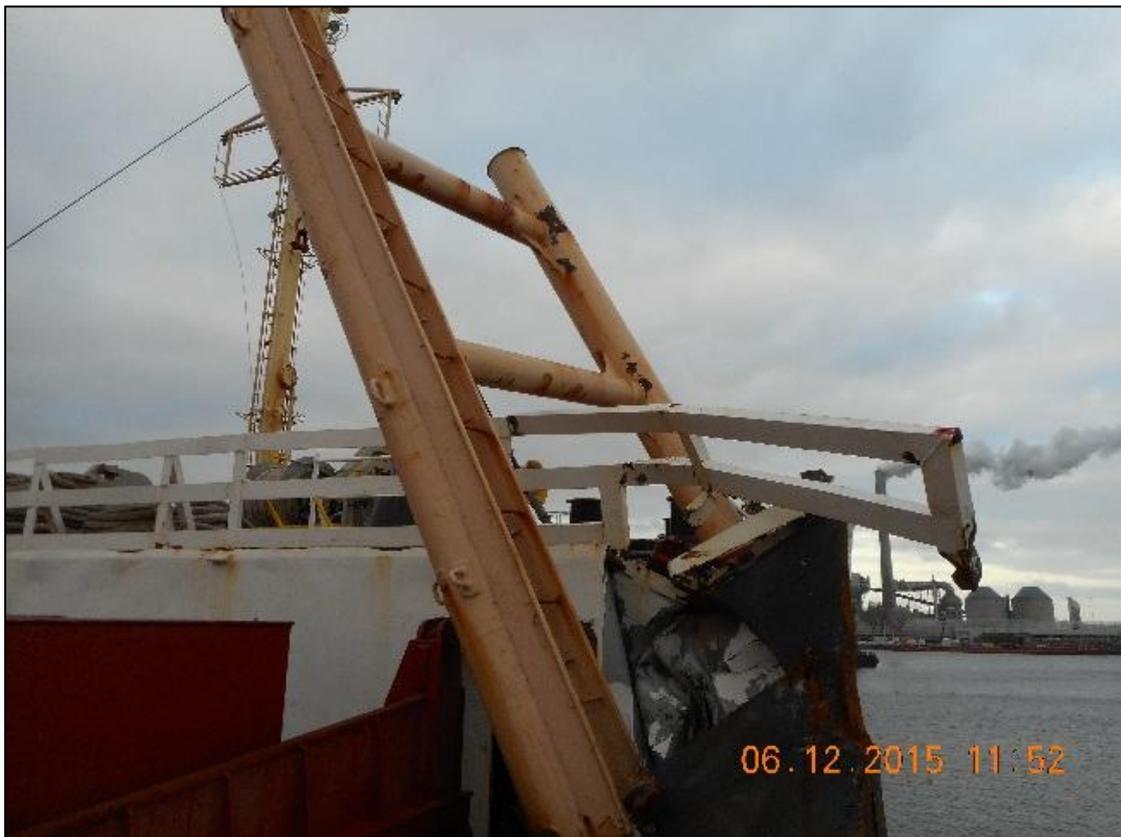
**Figure 3b: View of damaged bulwark and log stanchion on *Maraki***

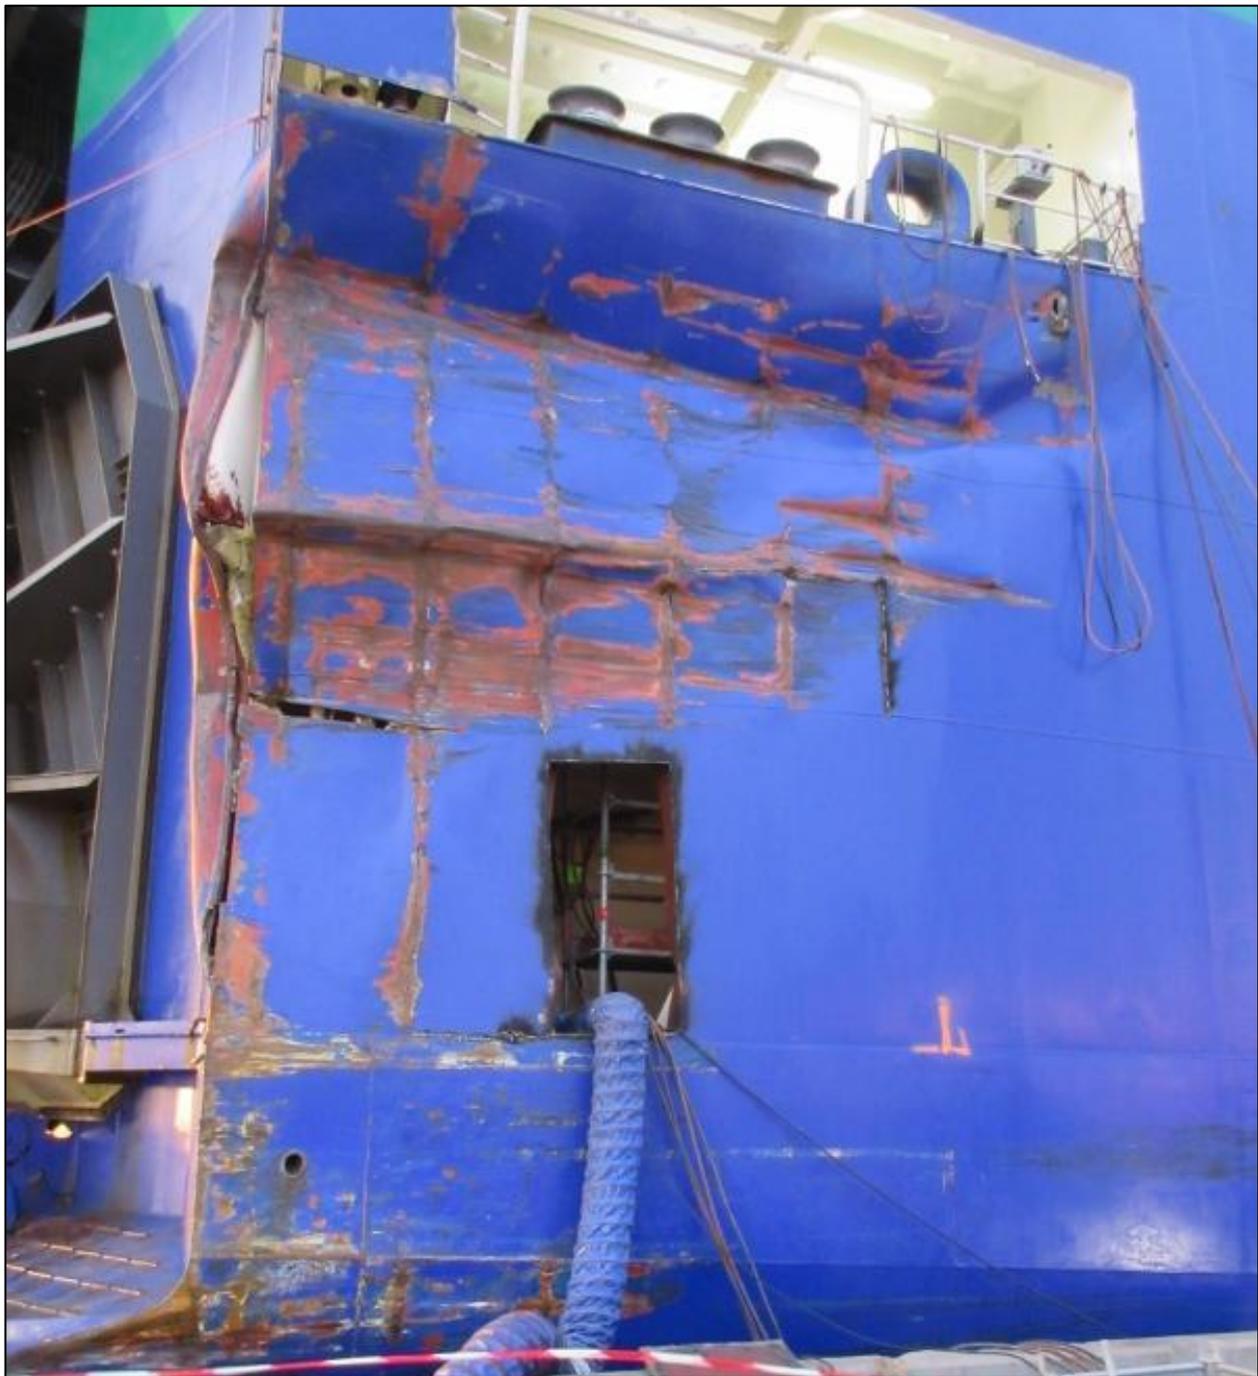
*Ivory Arrow's* Class surveyor reported damages to the starboard transom corner between car decks nos. 5 and 7 up to 9 frames.

Internal structural members were also damaged (Figure 4).

**Figure 4: *Ivory Arrow's* damaged starboard transom**

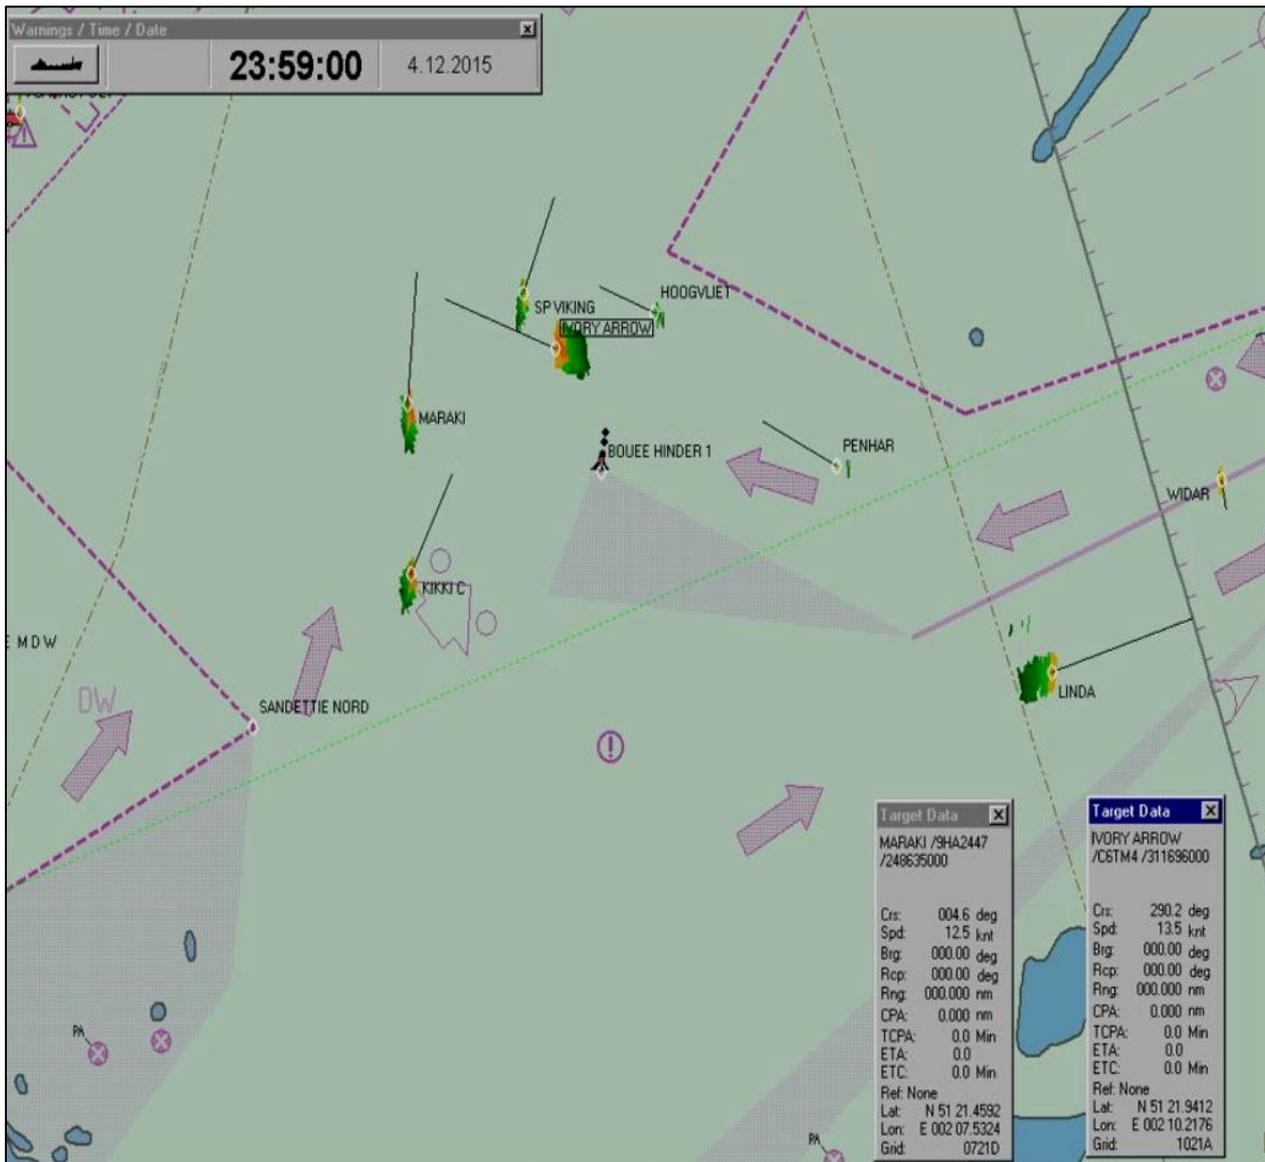
At about 2359, he initiated a helm order to come around a heading of 075°; assuming that *Ivory Arrow* would maintain her course (Figure 5). No signals were sounded to indicate her manoeuvre to starboard and the distance between the two vessels quickly decreased.

**Figure 5: VTS image showing relative position of *Maraki*, *Ivory Arrow*, *SP Viking* and *Hoogvliet* at 2359**

of *Ivory Arrow* being hampered in her manoeuvre to turn to starboard by the slow moving vessels *SP Viking* and *Hoogvliet* (Figure 5).
