Editorial

This edition of **CHIRP** Maritime Feedback covers a wide range of incidents, and it is encouraging to see reports from the leisure and fishing sectors. Please keep them coming!

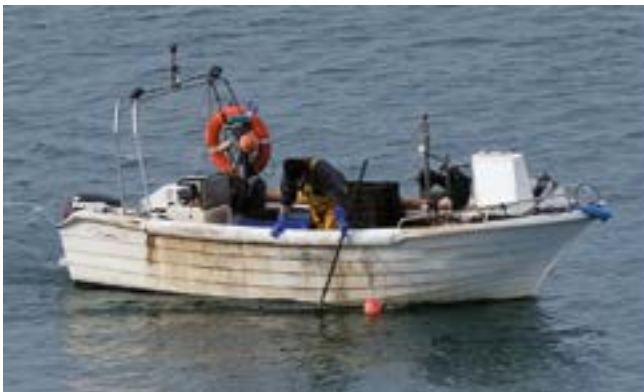
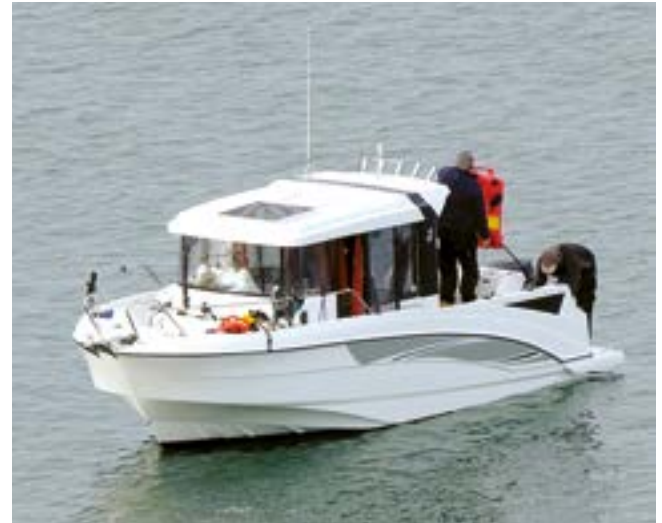
Recently, I observed a local fisherman clearly demonstrating an example of what is wrong with the fishing industry. I attach photographs which help best explain my concern for his safety.

In this case the fisherman returned to port safely, but it is sad to see that, despite the efforts to warn fishermen, there is still such a low level of personal safety awareness, not least in working without a lifejacket.

A small leisure vessel used for angling – no lifejackets being worn.

The Maritime Advisory Board discussed these reports and commented that the main issue is not the activity that the fishermen were engaged in, but rather the problems that could arise if any of the occupants fell overboard. All fishermen should take their personal safety into account by conducting a (dynamic) risk assessment into the possibility of falling overboard. By "dynamic" we mean, if necessary, think about the logical steps that are required to complete an unexpected task and the associated dangers that may arise and take the time to mitigate the risk. In cases like this, working outside the gunwales / bulwarks of the vessel, **IT IS YOUR LIFE AT RISK!** The risk assessment might include the following;

- A Personal Floatation Device (PFD) is an absolute must for all personnel involved in maritime leisure activities, and in the commercial fishing sector. PFD's can be "constant wear" and must be worn outside any other clothing such as waterproofs. They do not obstruct any activity.
- Consider wearing buoyant clothing – depending upon the activity, several types of buoyant clothing are available.
- For single-handed operations, who knows where you are and what time you are expected to return?

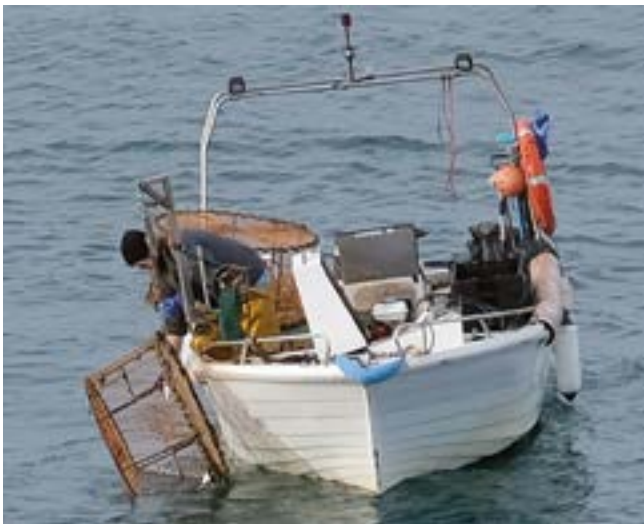
A small fishing vessel – the sole occupant is not wearing any floatation aid.

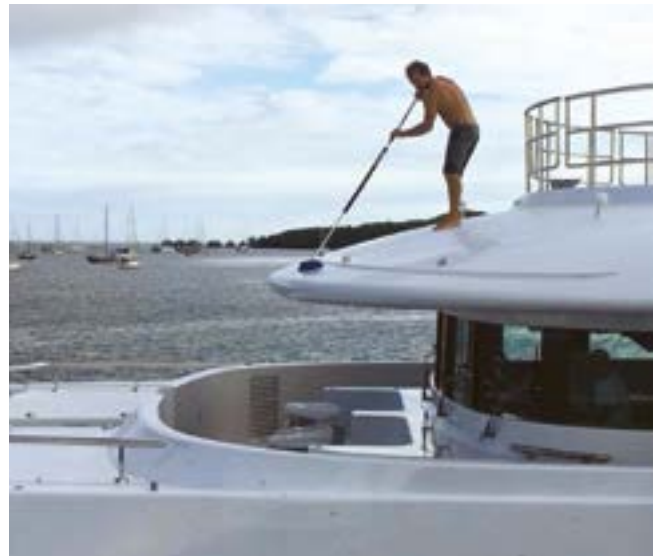
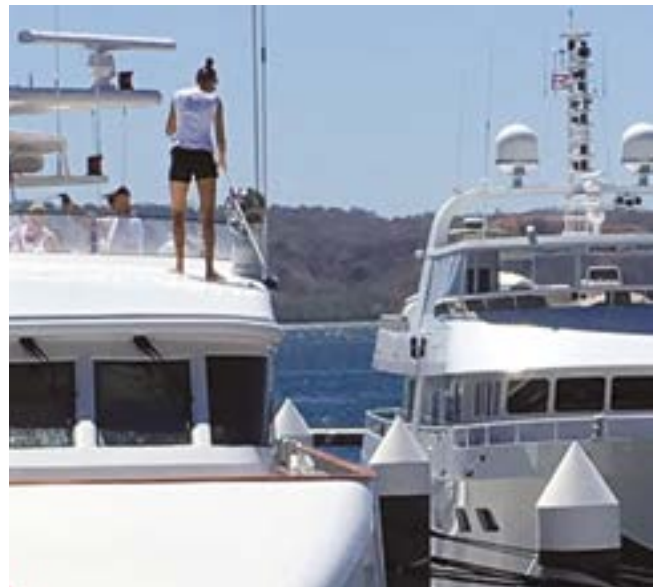
Whilst berthed alongside in Costa Rica, a yacht arrived on the berth behind ours. We then witnessed an all too familiar sight, common in the yachting sector. Crew members were repeatedly seen accessing the bow of the yacht when washing down – in doing so, they exposed themselves to considerable risk. Initially it was clear that the crew were not wearing any safety harnesses when working at height and outboard of any rails, even though they risked falling on to a concrete dock or into the sea. In addition, it was noted that the crew were all barefoot, and that they were working on an inclined brow that was covered in soap. Later it was learned that one of the crew members working on the same deck was actually the captain. Time and time again these incidents are being observed in yacht marinas, but it is hard to decide what to do, because gaining the crew's attention may cause them to fall.

Two examples of washing down and placing yourself in danger.

- Use of non-slip footwear is recommended as opposed to working barefoot or wearing flip flops on a slippery soapy surface.

- Consider a waist belt harness when accessing areas where there is the potential to fall.
- Use of longer-handled tools and standing behind a rail is a simple and effective method to ensure your safety when accessing areas identified as potentially hazardous.
- In certain circumstances (but not always), a personal floatation device (PFD) may be helpful.
- Although both of these photographs were taken within a port, the timing and location of conducting such work should always be considered.

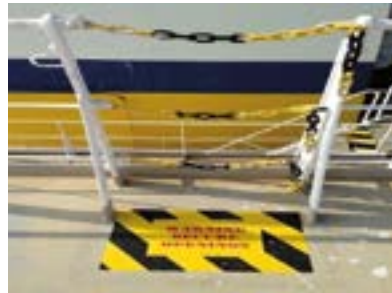
Any safety chains or openings in handrails should be secured at all times when not in use. This ship has highlighted the safety chains and has reminded users to secure the openings after use.

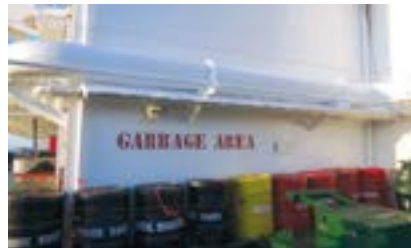
The garbage area on this ship is now highlighted, and they have fitted a small canopy above the drums so that the area is protected from rain and any soot from the funnel. In addition, they have placed additional waste bins in each cabin and public room specifically for plastic, in order to aid segregation.

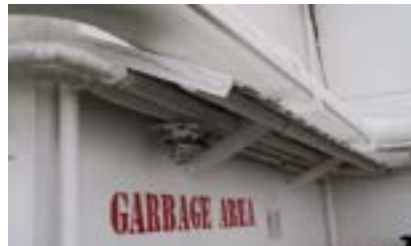
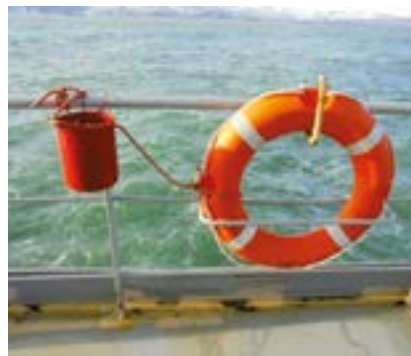
Who hasn't seen lifebuoy lines get into a tangle which would cause problems if the lifebuoy needed to be rapidly deployed? Here is a simple solution where the rope is coiled in a container and "stored" ready for immediate release.

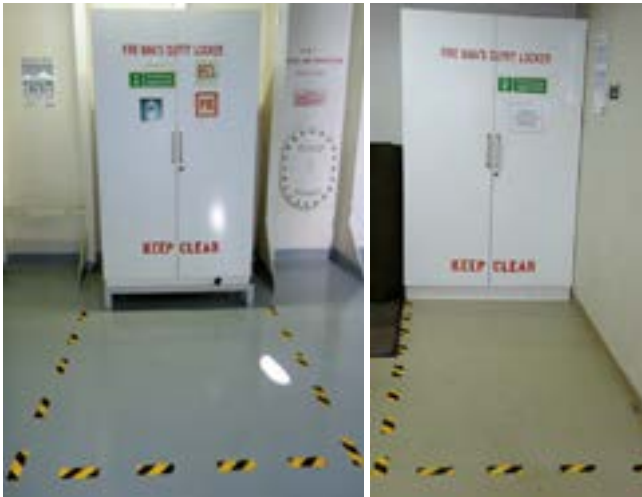
On this vessel, the crew have placed boundary markings and KEEP CLEAR notices beside the Fireman’s outfit lockers. The lockers should always be clear from any obstructions and this will assist in getting access to the fireman’s outfit and also gives space to change into the equipment in the event of a fire when time is of the essence.
